Materials Pre-Purchased for: 117 Hatch Avenue

117 Hatch Ave
Saint Paul, MN 55106

ASBESTOS AND LEAD-BASED PAINT SURVEY

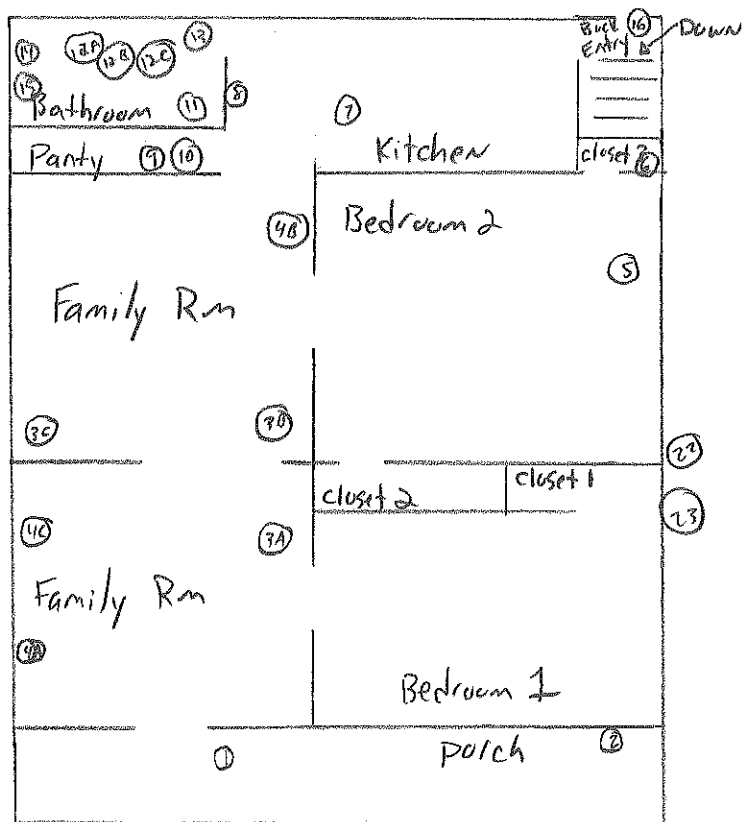
Asbestos
Sample
Locations

main Floor

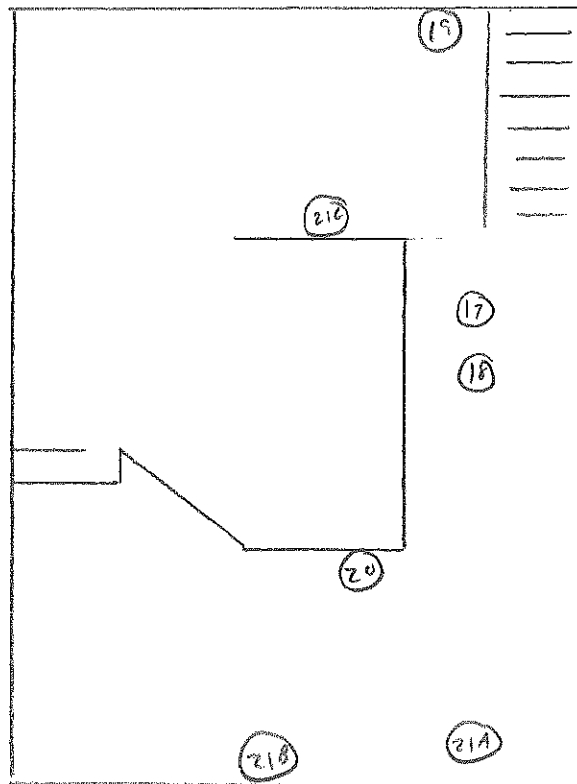
Asbestos
Sample
Locations

Basement

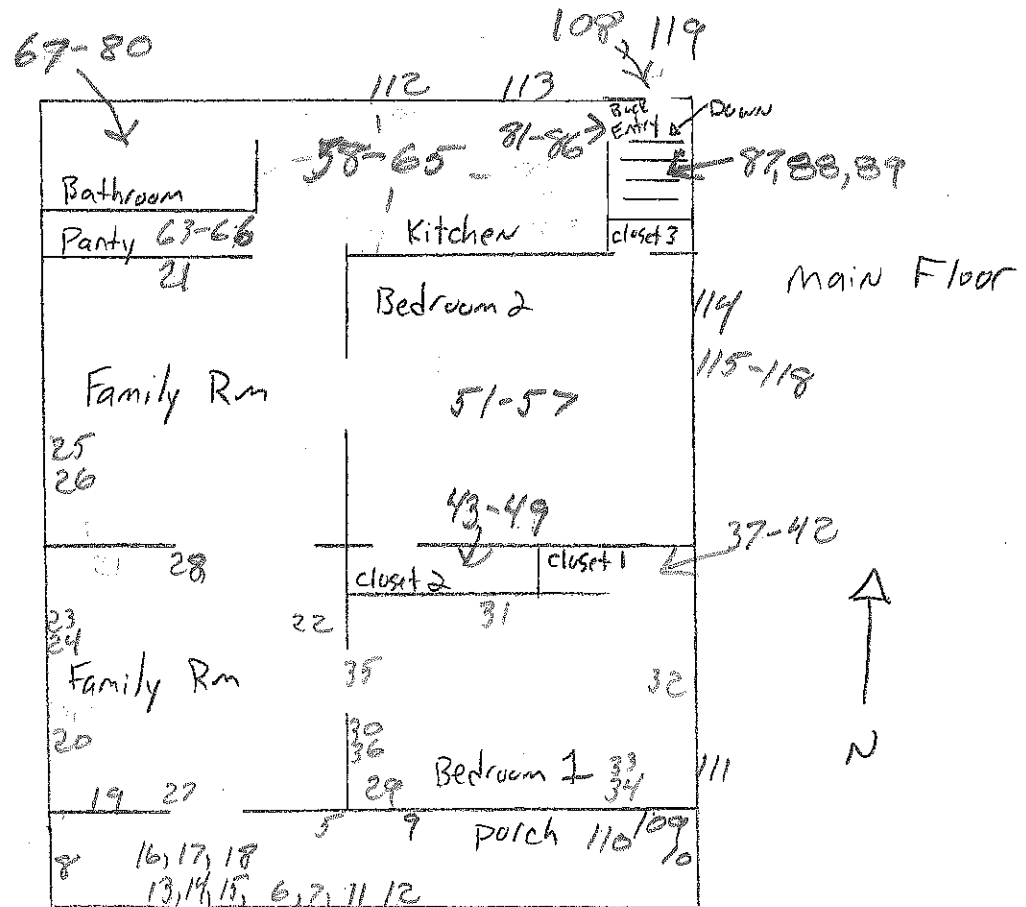
Lead
Sample
Locations

Hatch

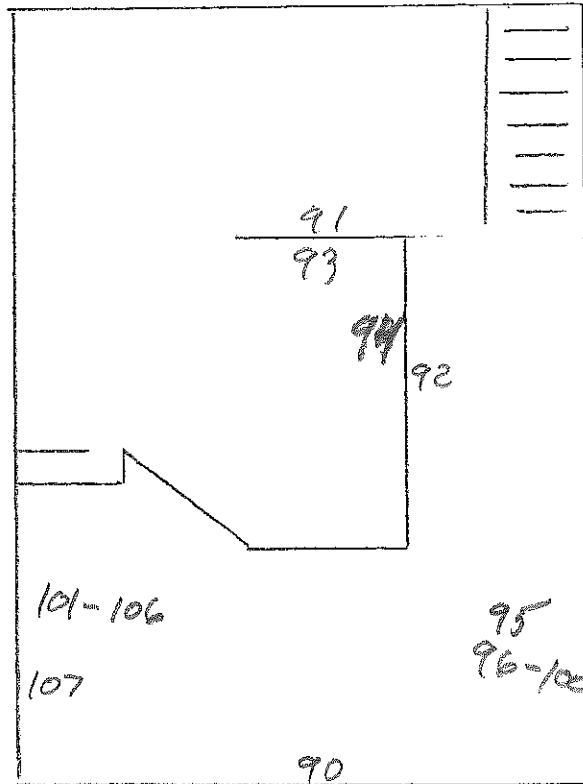
lead
Sample
locations

Basement
